TX119LEBR

"EGO" 8" Lavatory Faucet w/ 1¼" Pop-Up Waste

TX119LESBR

"EGO II" 8" Lavatory Faucet w/ 1¼" Pop-Up Waste

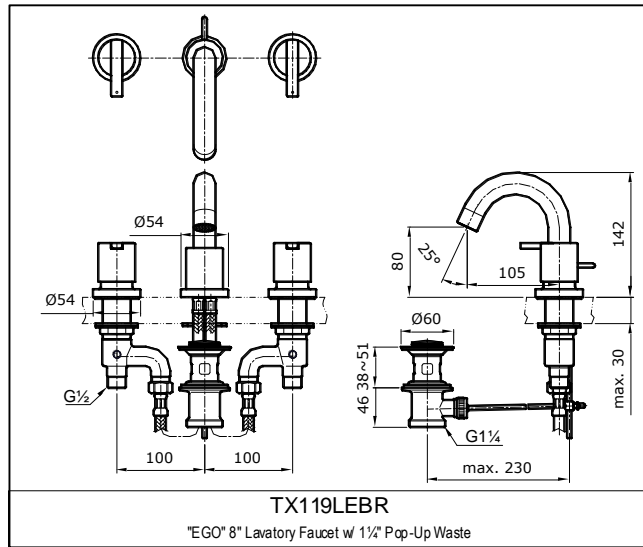
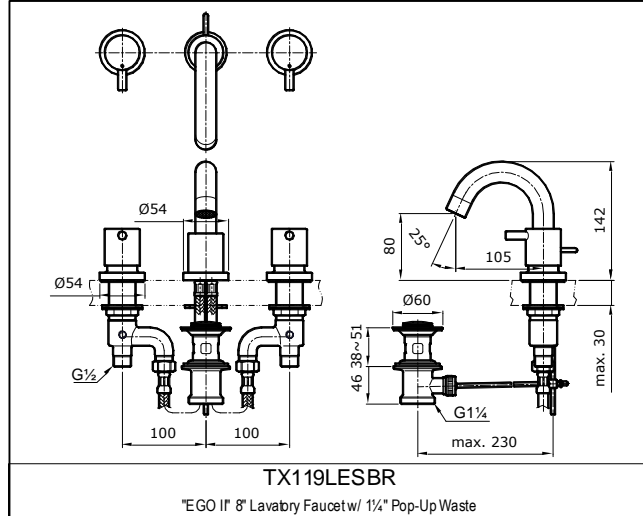
SPECIFICATIONS

1. Water supply pressure : 0.05 ~ 0.75 MPa.
2. Ensure that water supply is clean (No Sand, Dirt, Etc.)

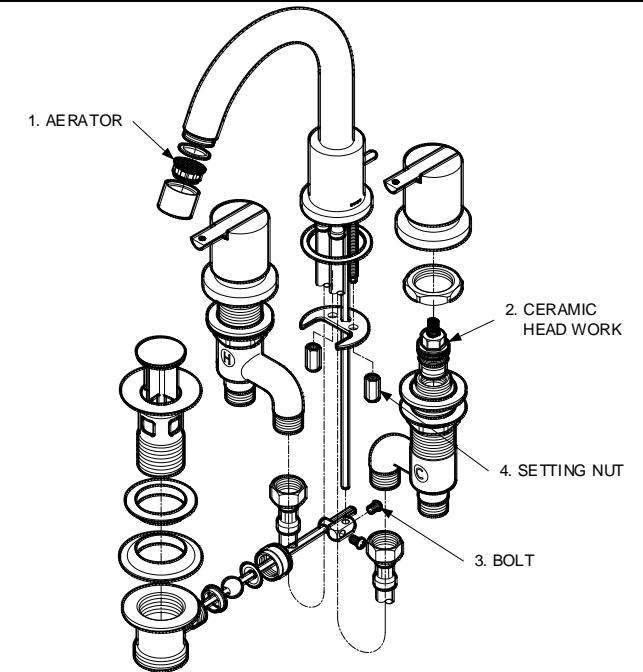
TROUBLESHOOTING

PROBLEM	CHECK POINT	SOLUTION
Flow rate unsatisfactory	1	Remove and clean
Water leaks around the handle	2	Tighten
Plug cannot open and close	3	Tighten
Body swinging	4	Tighten

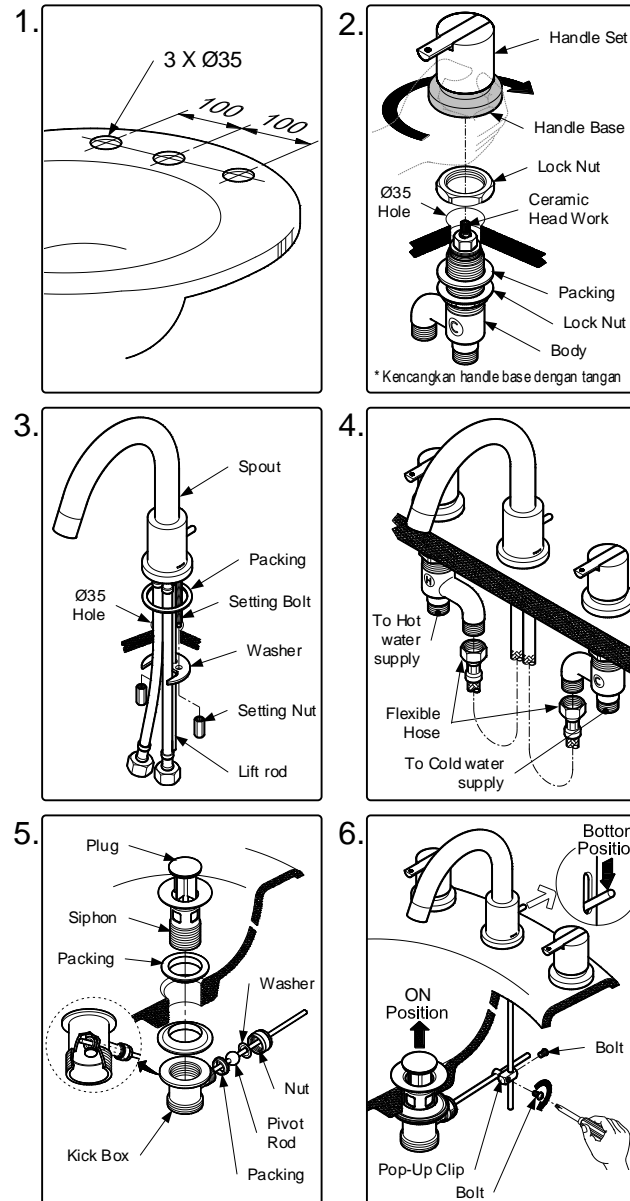
PEMASANGAN

1. Jangan gunakan bahan pembersih yang bersifat abrasif seperti deterjen yang mengandung asam klorida, tinner, bubuk polishing dan sikat nilon.
2. Karena model produk terus mengalami pembaharuan, aktual produk mungkin tidak sama dengan gambar, tapi prinsip dasar pemasangan adalah sama.

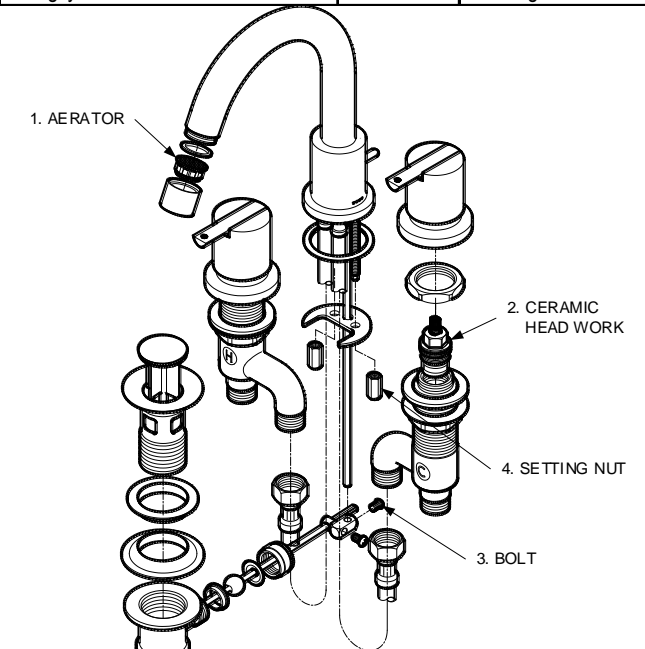
PENYELESAIAN MASLAH

MASALAH	POIN PERIKSA	SOLUSI
Laju aliran tidak memuaskan	1	Lepas dan bersihkan
Air bocor disekitar handle	2	Kencangkan
Plug tidak bisa membukadan menutup	3	Kencangkan
Bodi goyah	4	Kencangkan
